AM389x Sitara ARM Microprocessors (MPUs) Revision 1.0

Silicon Errata

Literature Number: SPRZ327
November 2010

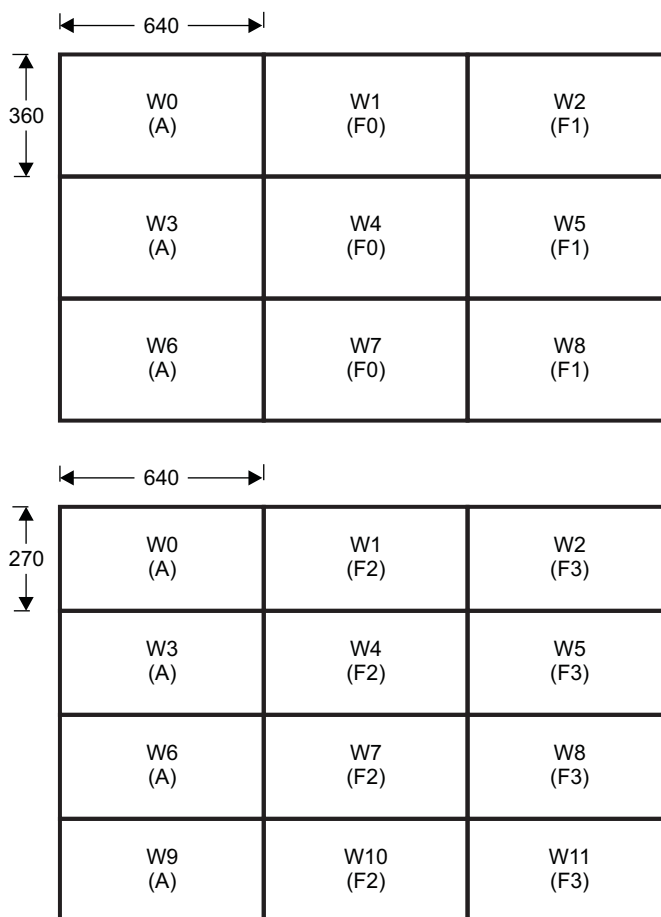
Figure 3. Descriptor Layout

In the case of 3x3-to-3x4 layout change, the free channels used for the two layouts are different. Therefore, when the layout changes the VPDMA does not block on the free channels (F2 and F3) of the 3x4 descriptors because they are not used earlier. Then, the VPDMA stalls on the actual channel (A) for window W0. At the same time, the last row of 3x3 descriptors is being transferred. When the last line of the first window in the last row (W6) completes, the actual channel (A) is unblocked. But, the client is busy transferring the last line of the remaining windows (W7 and W8). This causes the above mentioned condition, which results in a list hang and the display starts displaying the COMP background color.

This hang does not happen for layouts if there is a dummy descriptor for that layout because it stalls the VPDMA list until the last pixel of the frame. Dummy descriptors are used when the last window in a frame does not end with the frame's bottom-right boundary (see [Figure 3](#) and [Figure 4](#)).
