# **TMS320C6A816x Integra DSP+ARM Processors Revision 1.0**

## **Silicon Errata**

Literature Number: SPRZ328  
November 2010

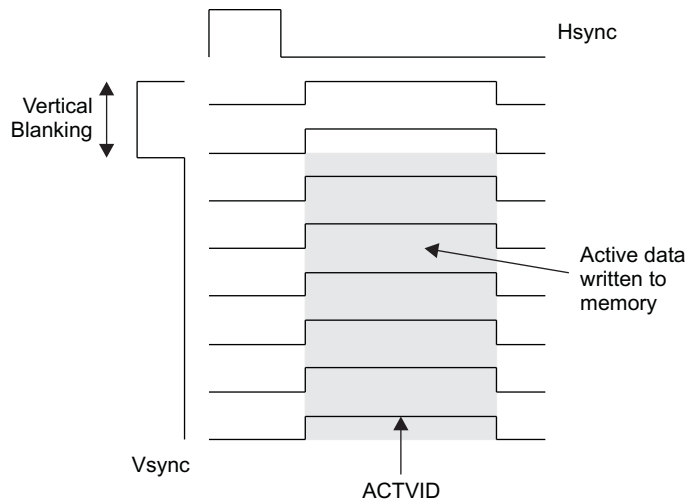
**Figure 2. ACTVID Signal Active for All Lines of Incoming Data**

**Details:** The VIP port supports a discrete sync capture mode where the ACTVID signal is used to determine the active region of the video and then the VPDMA writes this active video frame to memory. However, with some external video decoders, this mode does not work by default.

**Workaround:** The VIP parser requires that the ACTVID signal is active for all lines of the incoming data, including the vertical blanking region. The vertical blanking region, itself, is not written to memory by the VPDMA. [Figure 2](#) illustrates this.

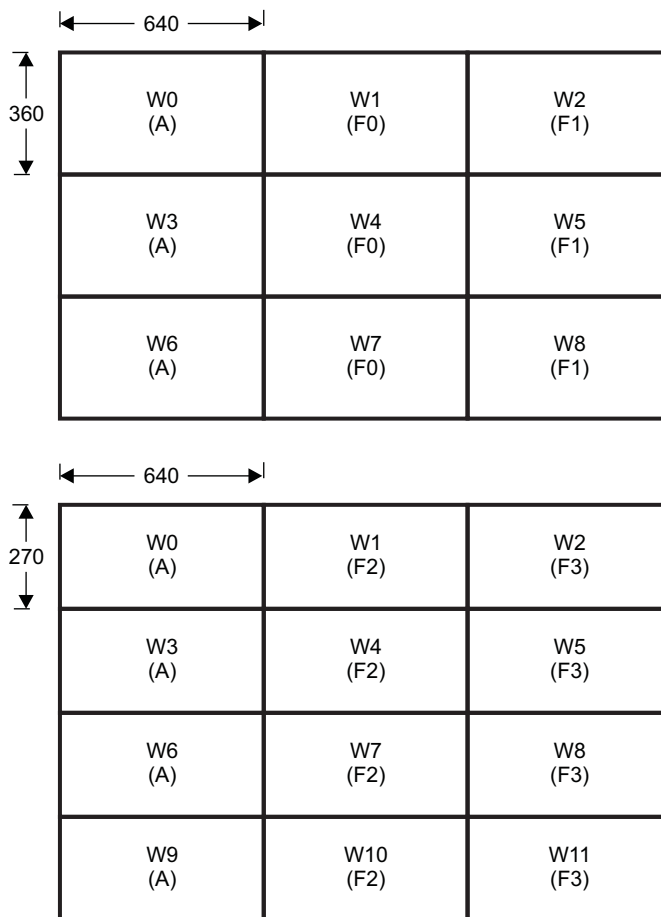
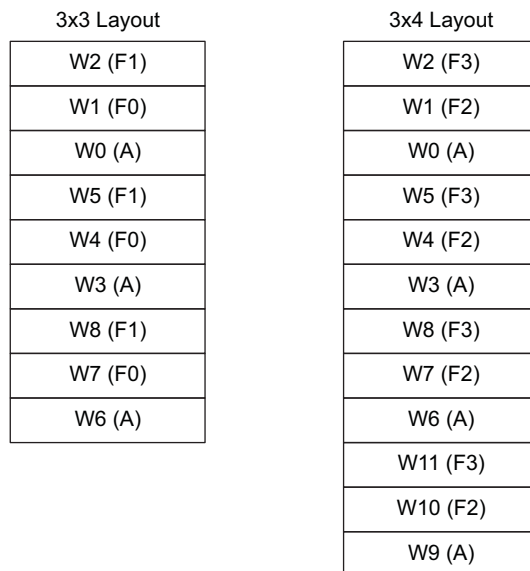
**Figure 3. Descriptor Layout**

In the case of 3x3-to-3x4 layout change, the free channels used for the two layouts are different. Therefore, when the layout changes the VPDMA does not block on the free channels (F2 and F3) of the 3x4 descriptors because they are not used earlier. Then, the VPDMA stalls on the actual channel (A) for window W0. At the same time, the last row of 3x3 descriptors is being transferred. When the last line of the first window in the last row (W6) completes, the actual channel (A) is unblocked. But, the client is busy transferring the last line of the remaining windows (W7 and W8). This causes the above mentioned condition, which results in a list hang and the display starts displaying the COMP background color.

This hang does not happen for layouts if there is a dummy descriptor for that layout because it stalls the VPDMA list until the last pixel of the frame. Dummy descriptors are used when the last window in a frame does not end with the frame's bottom-right boundary (see [Figure 3](#) and [Figure 4](#)).
